Attached algae or “periphyton” growth peaks in spring at Lake Tahoe

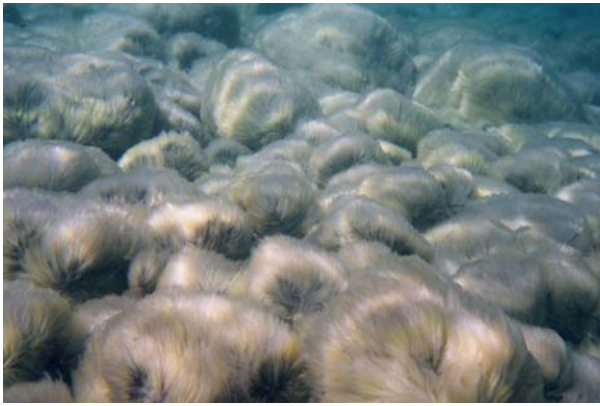
Attached algae or "periphyton" blankets the rocks underwater in certain locations during the spring months

Spring, with its increasing solar radiation, is the time when growth of attached algae (periphyton) is usually the heaviest. During this period of often abundant growth, this algae appears in multiple colors (whitish, tan or green) and can take the form of slimy, feathery or stringy growths on rocks in the shallow nearshore zone. It also actively grows on pier pilings, surface sediments, boat hulls and other available surfaces. The amount of growth is not uniform around the lake. Periphyton growth depends on the availability of the nutrients nitrogen and phosphorus that drain into the nearshore from the surrounding landscape. During wet winters, the lake receives higher amounts of nitrogen and phosphorus from groundwater and surface runoff sources. We would expect this to favor heavier periphyton growth this year. Spring growth of periphyton is often heaviest in the northwest portion of the lake.

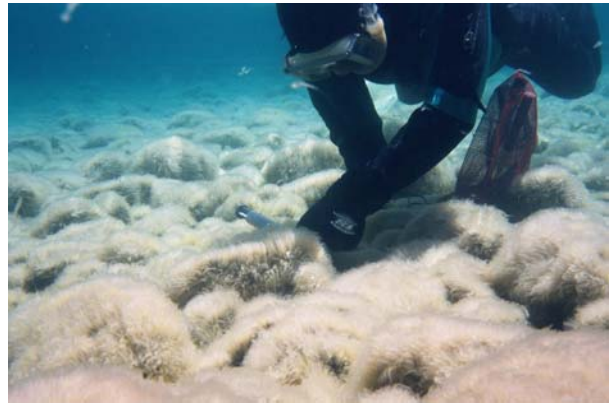
UC Davis researchers collect samples of the periphyton and compare growth from year-to-year and in various locations around the lake

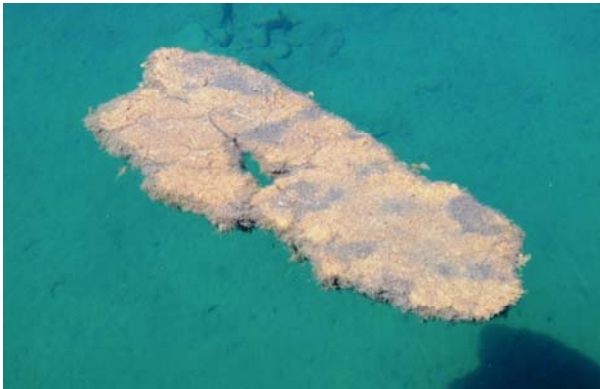
As the dead algae begins to decay, gas is trapped causing it to float to the surface

As the dead algae begin to decay, gas is trapped in the mat causing it to float and wash up along shore. Much also remains submerged gradually dispersing in the water column and along the bottom. Although there may be live cells in the sloughed material, the mats on the

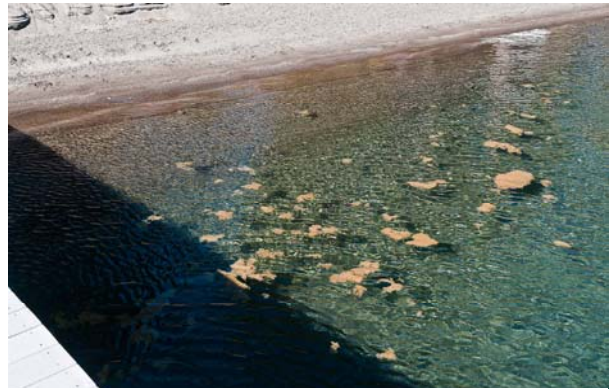
Mats of dead periphyton floating on the surface of Lake Tahoe (Photo by Bob Zimmerman, 2011)

Following a spring bloom, we often see aggregations or mats of periphyton—which have broken free or “sloughed” from rocks or other surfaces—floating on the surface or washed up along the shore. This is particularly common in the area from Pineland to Dollar Point but can be seen anywhere in the lake.

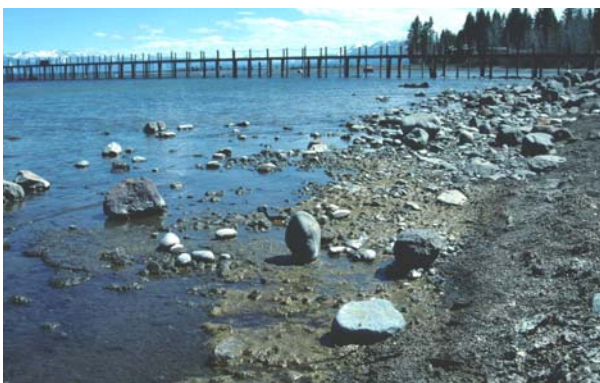
Dead algae floats to the surface and washes up along the north shore of Lake Tahoe

surface don't usually proliferate further into a larger bloom, rather they typically break apart, sink or wash up along shore where it can cause a particularly bad odor as it bakes in the sun.

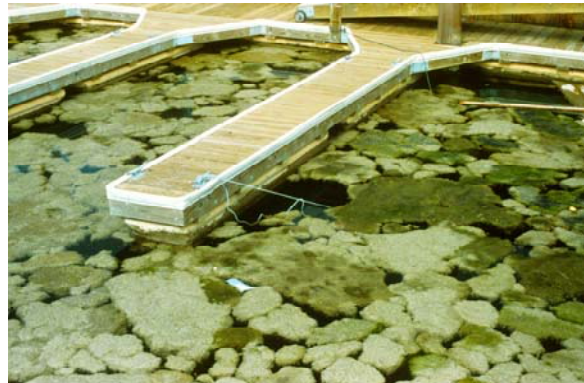
Algae mats in Tahoe City Marina after floating up from the bottom in spring 1983 (Photo by Bob Richards, 1983)
